Debris/Ice/TPS Assessment and Integrated Photographic Analysis of Shuttle Mission STS-65

*Gregory N. Katnik, Barry C. Bowen, J. Bradley Davis,
Vehicle Engineering/Mechanical System Division/ET Section,
Kennedy Space Center, Florida*

July 8, 1994

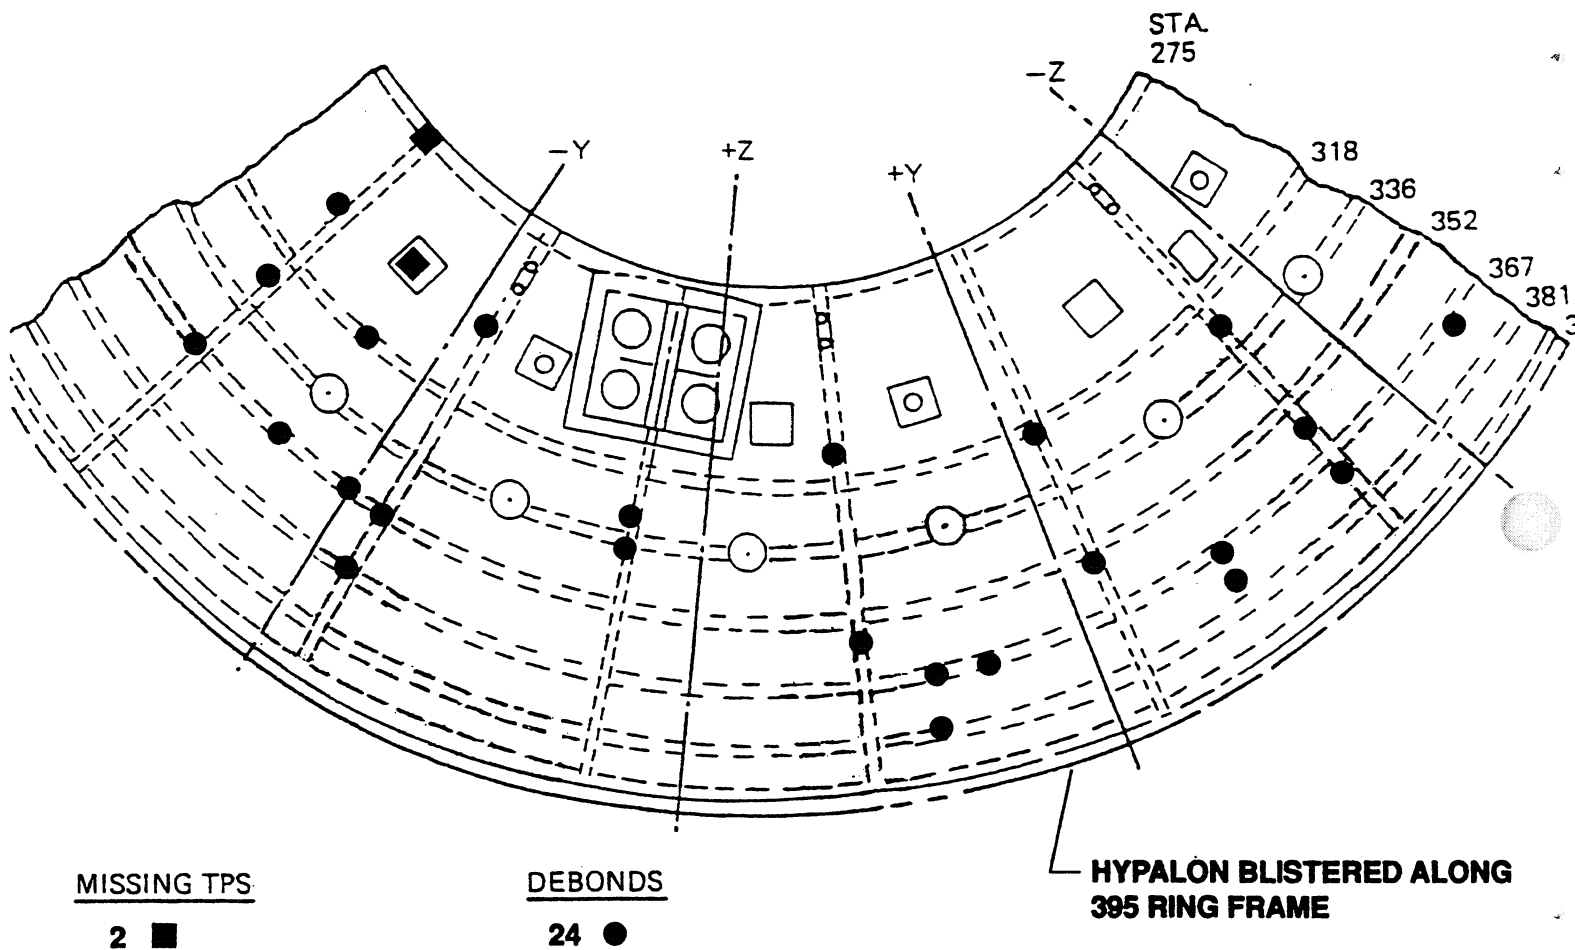
Figure 1 : RH SRB Frustum Debonds

The RH frustum had 24 MSA-2 debonds over fasteners. Two areas of missing TPS, 2"x1" and 1"x1" respectively, were located between the -Y and -Z axes and the 275 and 318 ring frames (Figure 1). Hypalon paint was blistered/missing along the 395 ring frame where BTA had been applied. Some of the underlying BTA was lightly sooted. The BSM aero heat shield covers had locked in the fully opened position.

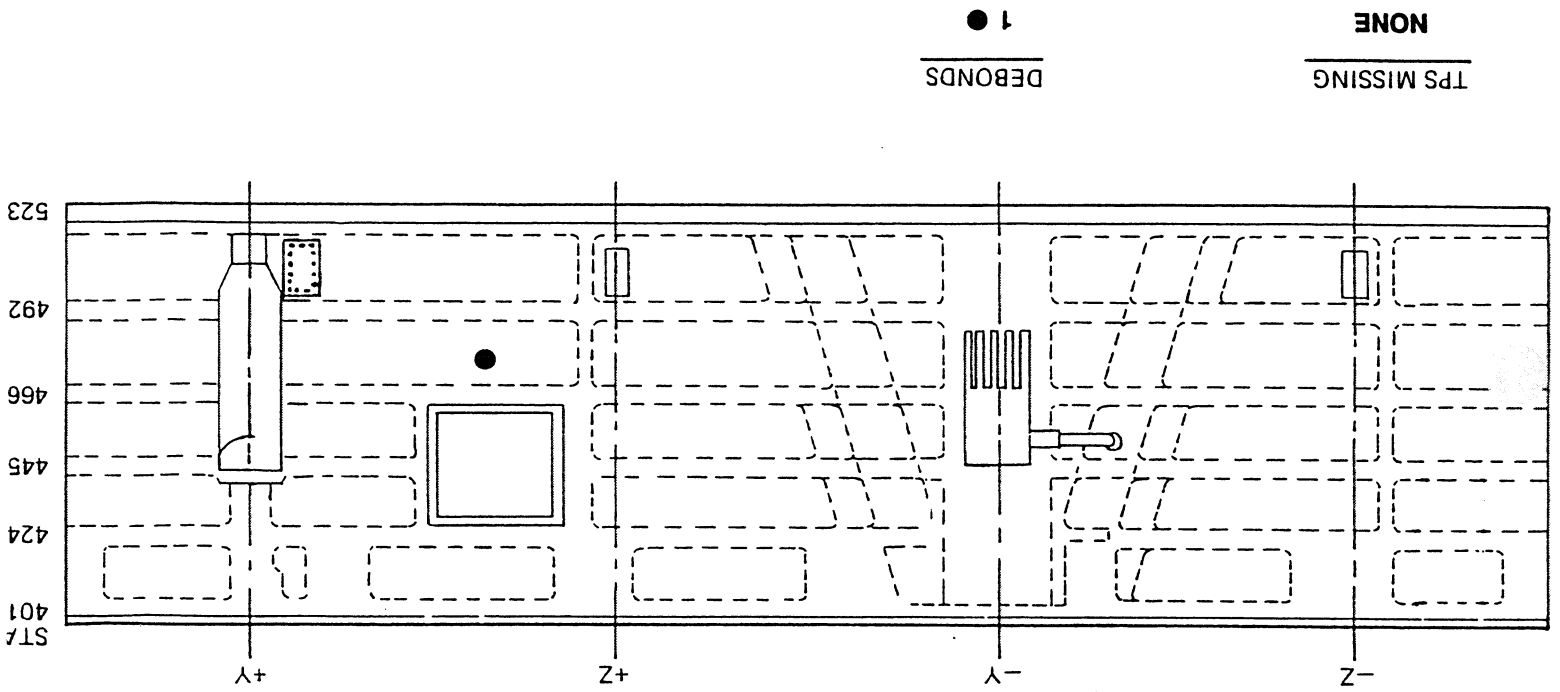
Figure 2 : RH Forward Assembly Debonds

The RH forward assembly exhibited no missing TPS but had one acreage debond aft of the flight door (Figure 2). Both RSS antennae covers/phenolic base plates were intact. Hypalon paint was blistered/missing over the areas where the BTA had been applied. The underlying BTA was not sooted. No pins were missing from the frustum severance ring.

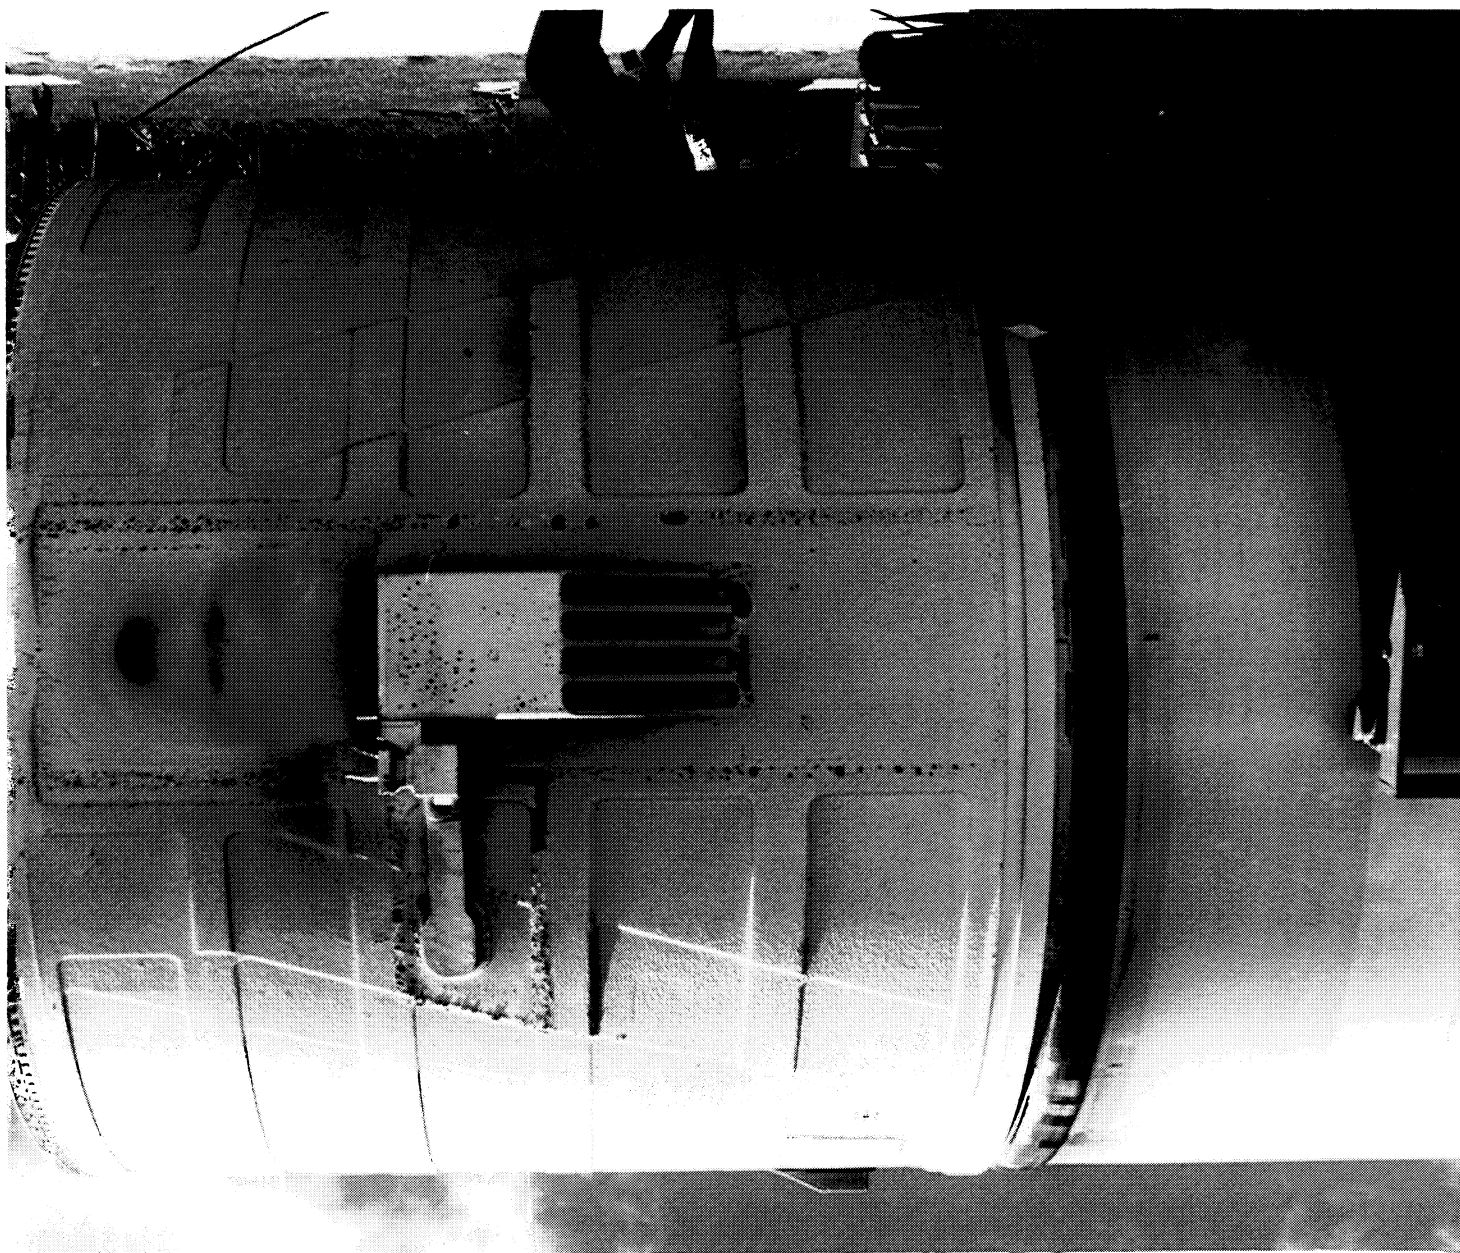
Photo 20 : RH Forward Assembly

Hypalon paint was blistered/missing where BTA closcouts had been applied

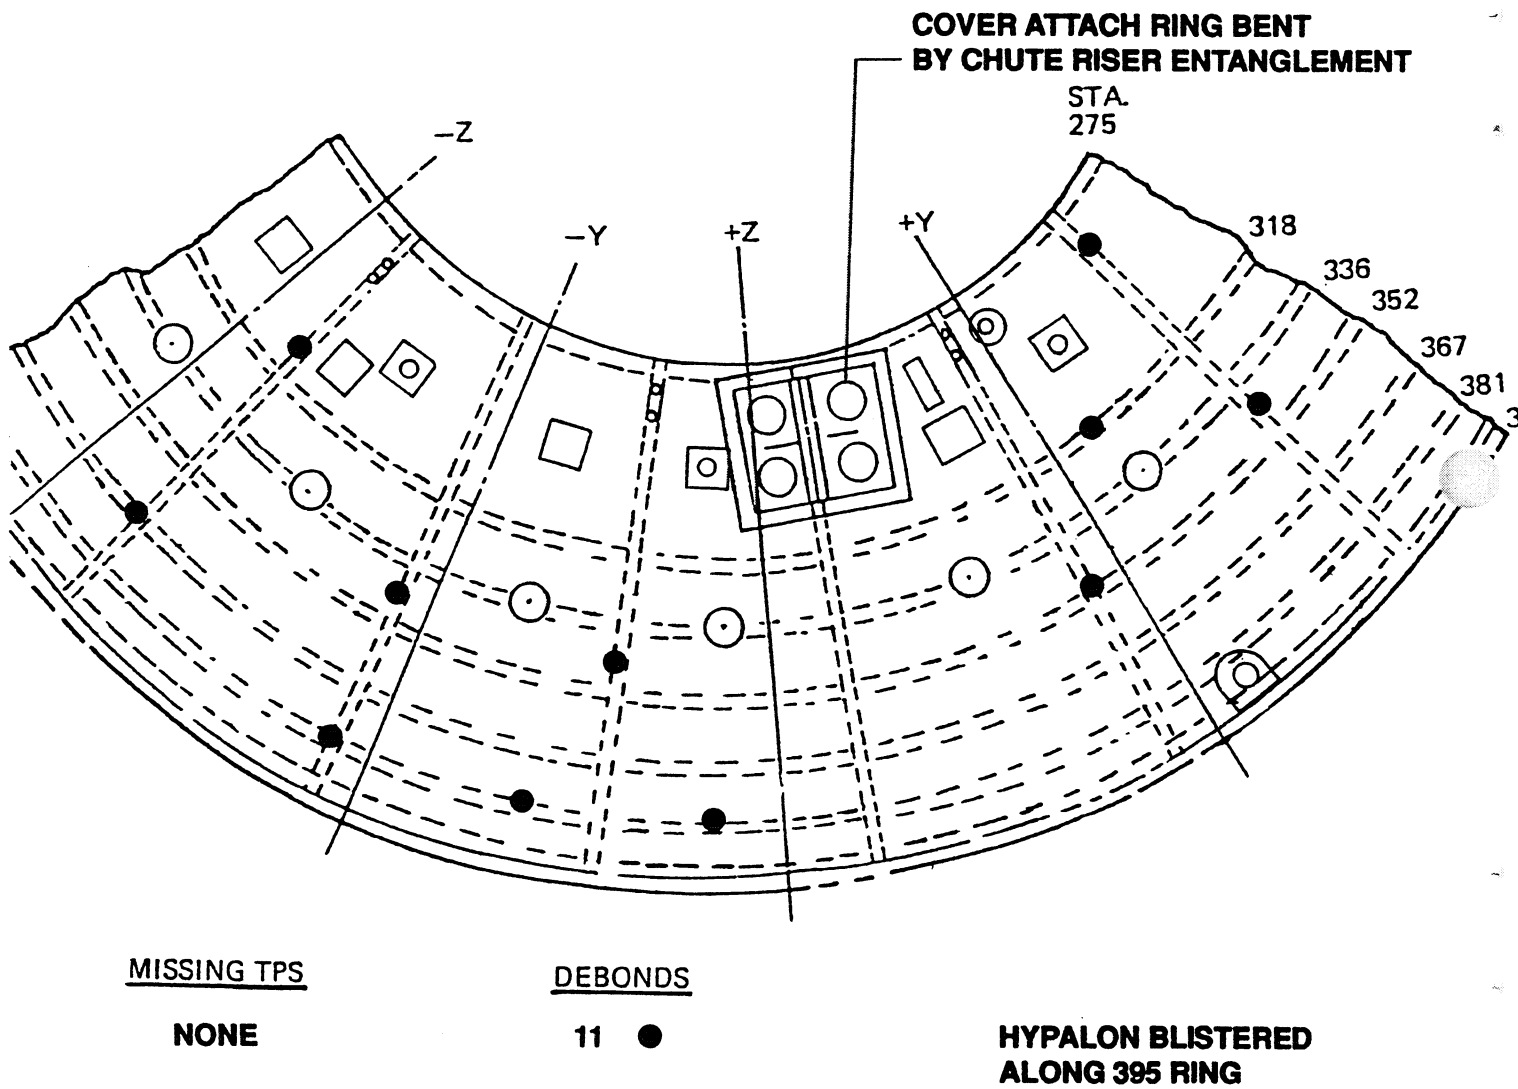
Figure 3 : LH Forward Frustum

The LH frustum was missing no TPS but had 11 MSA-2 debonds over fasteners. Hypalon paint was blistered/missing along the 395 ring frame where BTA had been applied. All BSM aero heat shield covers had locked in the fully opened position. However, the upper right cover was bent backward to the 90 degree position and the attach ring had been deformed by parachute riser entanglement (Figure 3).

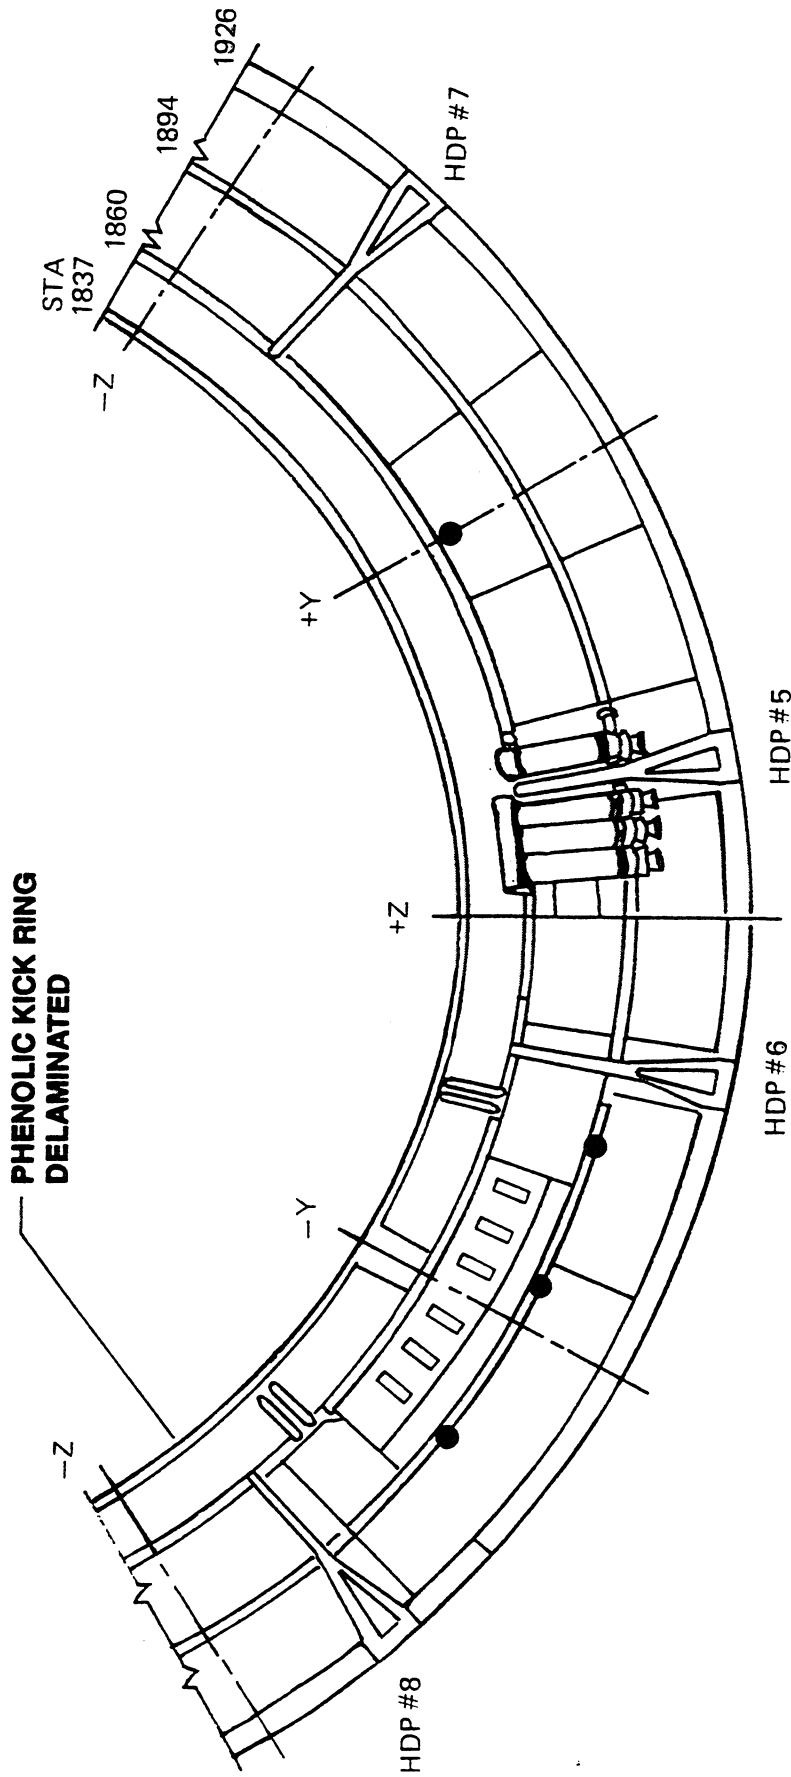
Figure 4 : LH Aft Skirt

The phenolic material on the kick ring was delaminated. Aft skirt acreage TPS was generally in good condition. However, three areas of MSA-2 were missing from fasteners near the 1894 ring frame between HDP #6 and #8 (Figure 4). Hypalon paint was blistered/ missing over areas where BTA had been applied. K5NA was missing from the BSM nozzles.

ALL HDP DCS PLUNGERS
STEATED PROPERLY

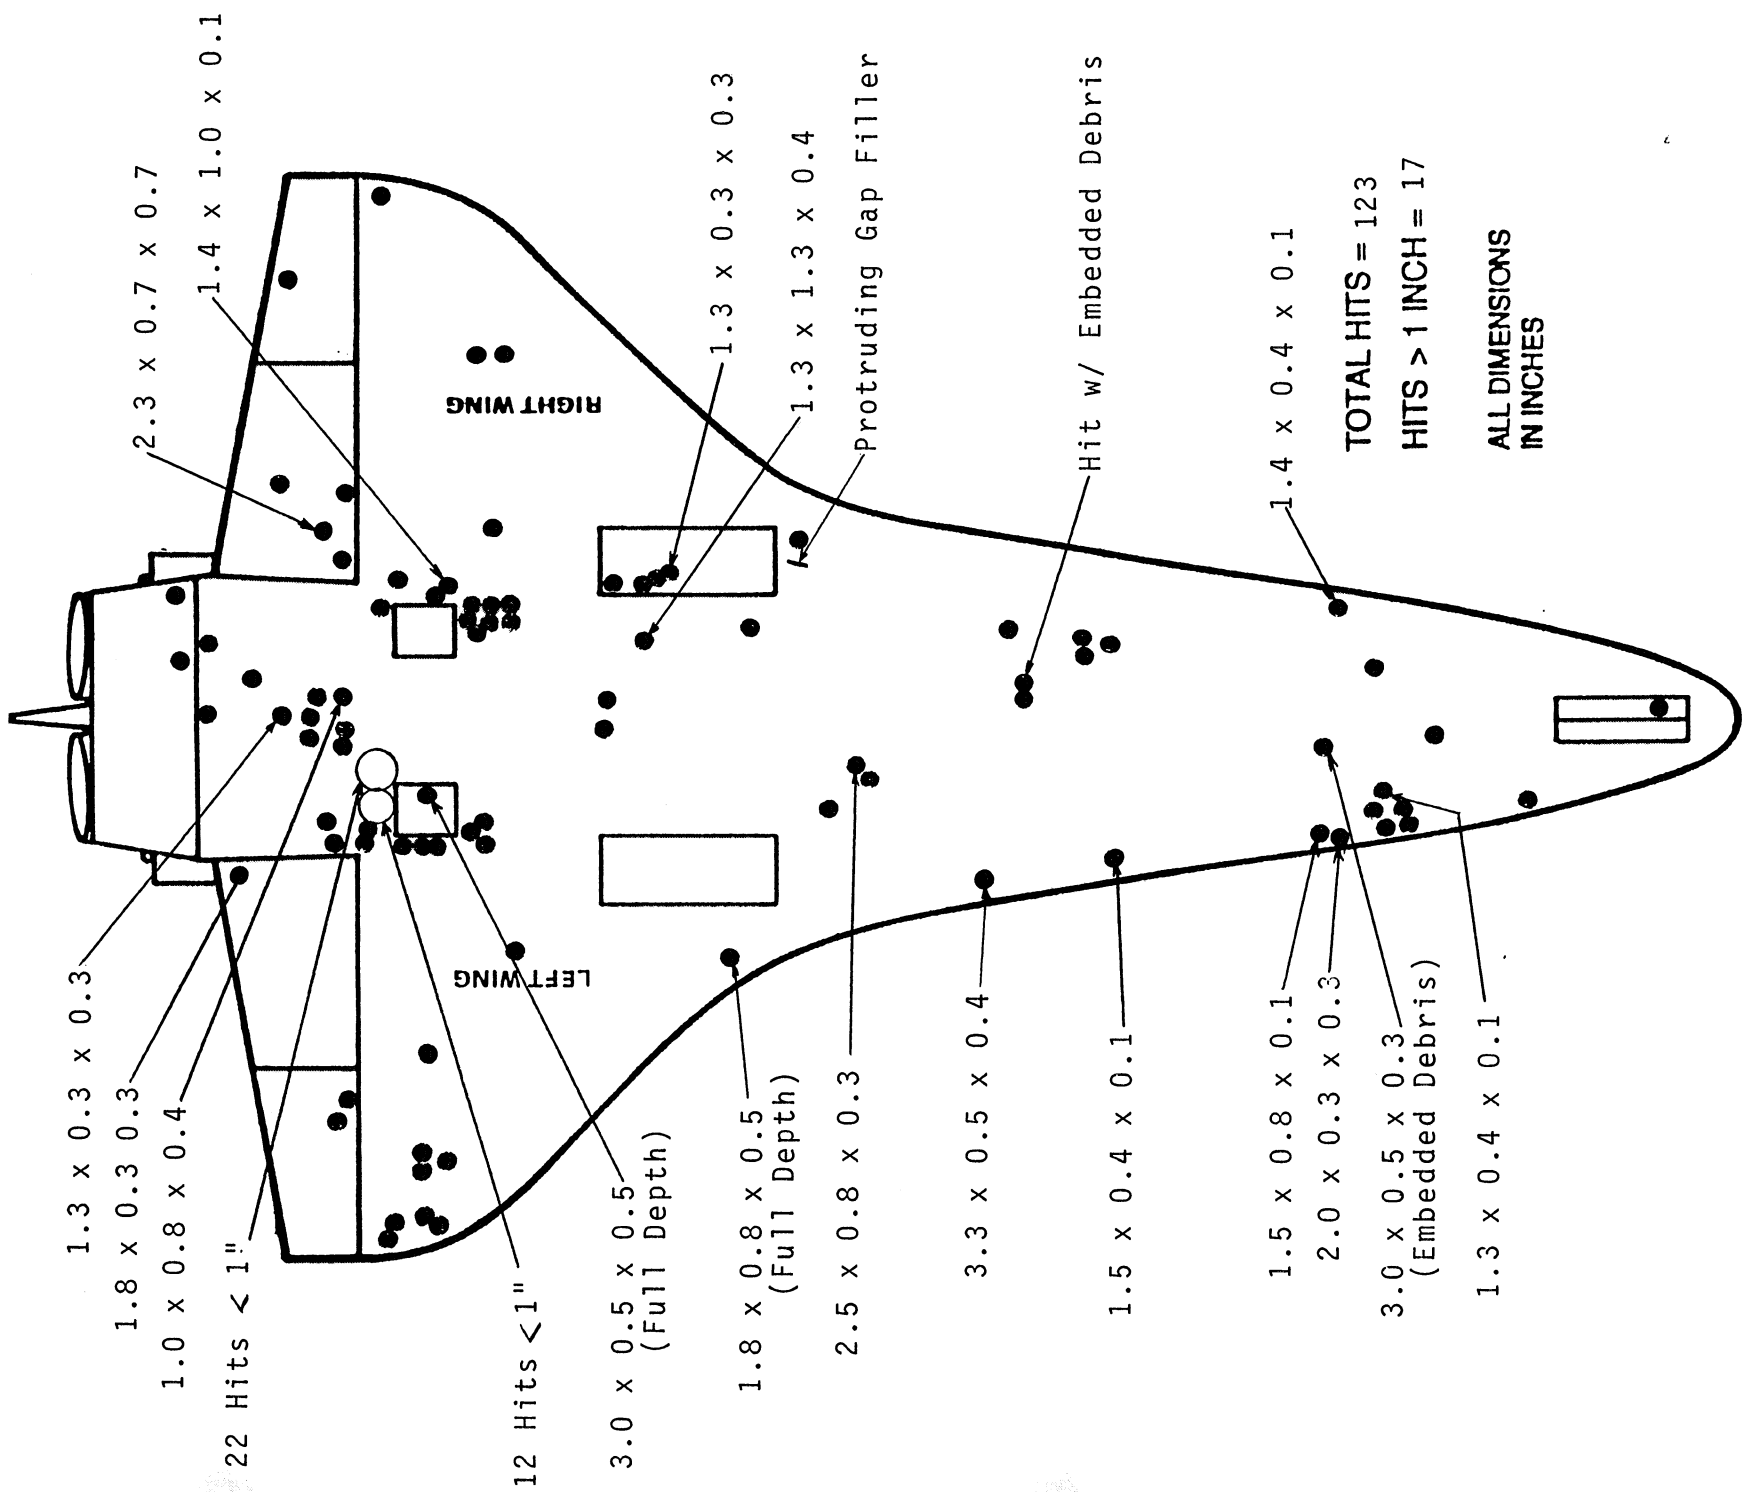
Figure 5 : Orbiter Lower Surface Debris Map

A post landing inspection of OV-102 after landing at KSC revealed the Orbiter TPS sustained a total of 151 hits, of which 21 had a major dimension of 1-inch or greater. The Orbiter lower surface had a total of 123 hits, of which 17 had a major dimension of 1-inch or greater. Based on these numbers and comparison to statistics from previous missions of similar configuration, the total number of debris hits was slightly greater than average and the number of hits 1-inch or larger was average. The ET/Orbiter separation devices functioned properly. No debris was found on the runway below the umbilical cavities.

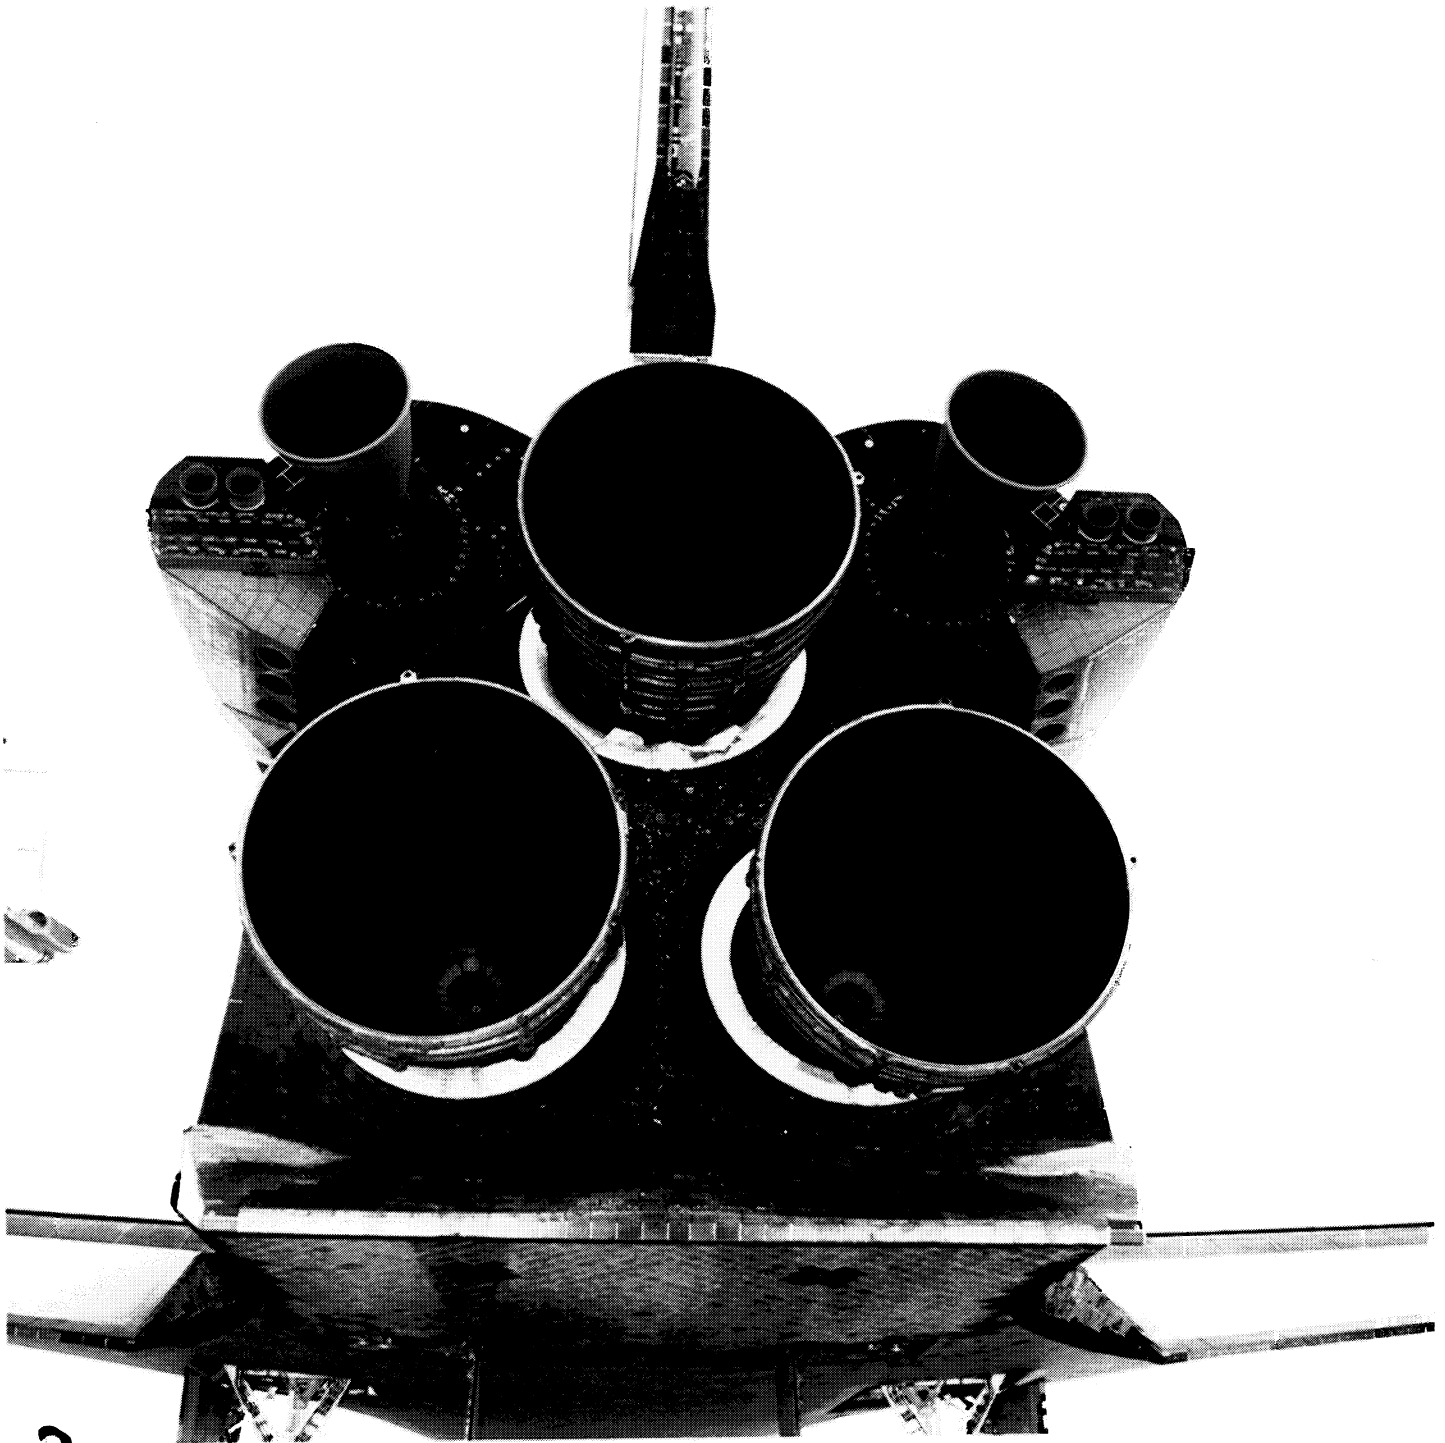
Photo 30 : Overall view of SSME and Base Heat Shield

Note damage to tiles on upper right surface of body flap and torn Dome Mounted Heat Shield closeout blankets at SSME #1 6:00 o'clock position

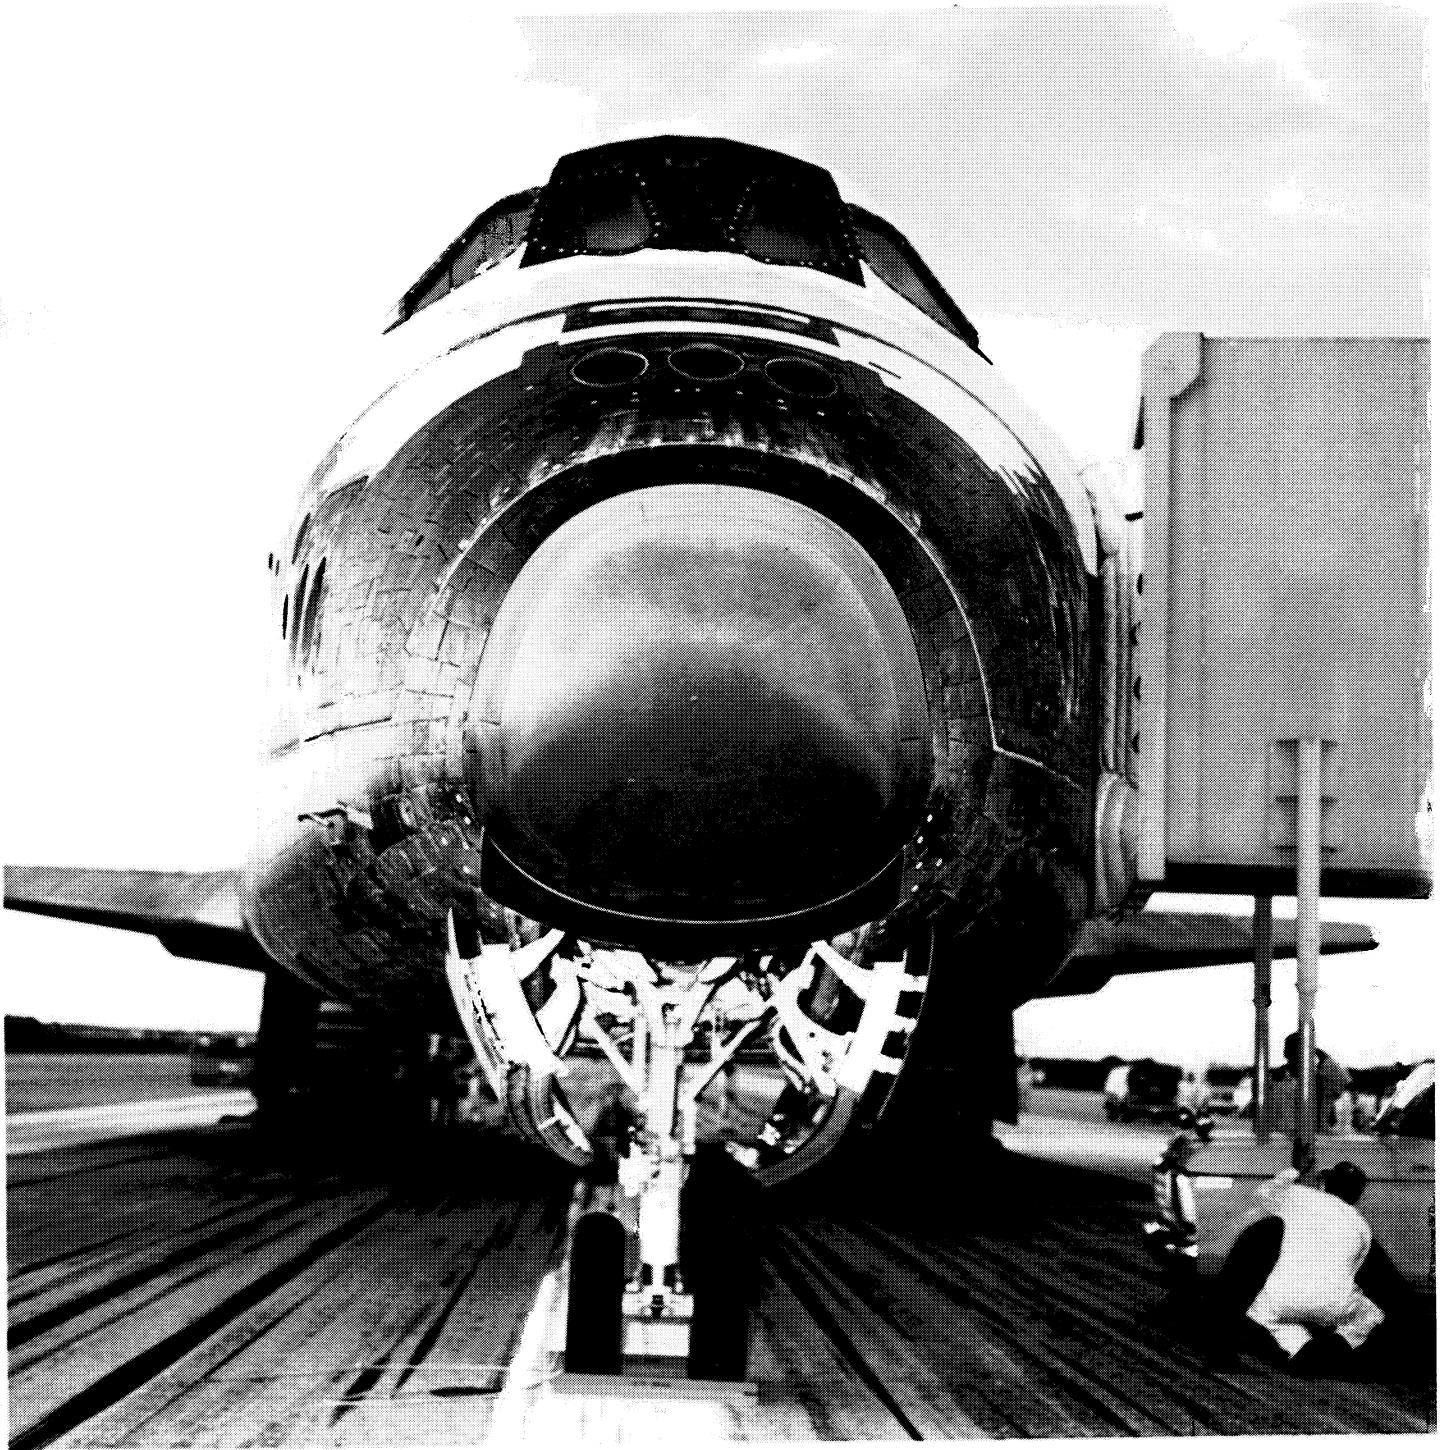
Photo 31 : Overall view of Orbiter nose and windows.

Orbiter windows #3 and #4 exhibited streaks and moderate-to-heavy hazing. Windows #2 and #5 exhibited light-to-moderate hazing. Only a very light haze was present on the other windows. Damage on the window perimeter tiles was less than usual.

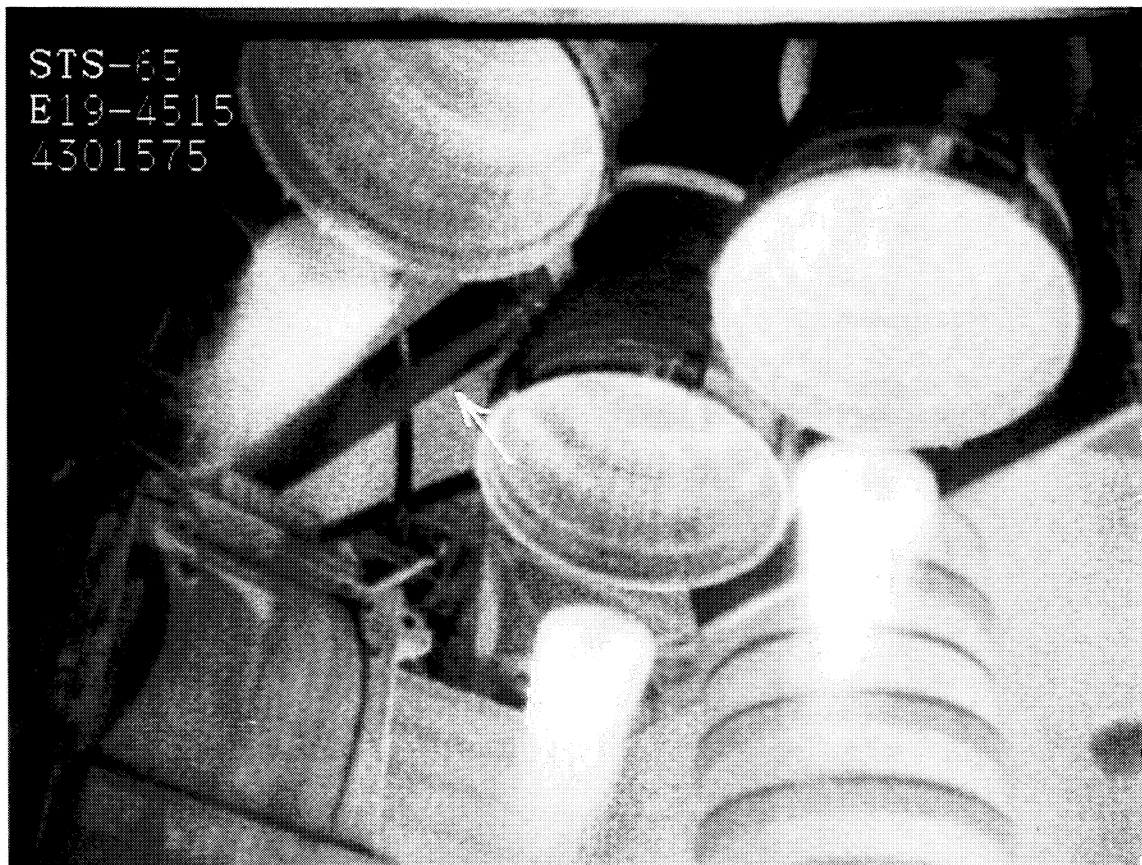
Figure 2.2.2 Flash in the SSME #1 plume
(Camera E-19)

A single orange flash was noted in the SSME #1 plume at T-2.2 seconds. (See Figure 2.2.2). A flash was also seen in the SSME #3 plume at 0.9 seconds MET. Both of these flashes may have been due to debris entering the plume. This event has been seen on earlier missions. No follow-up analysis has been requested.

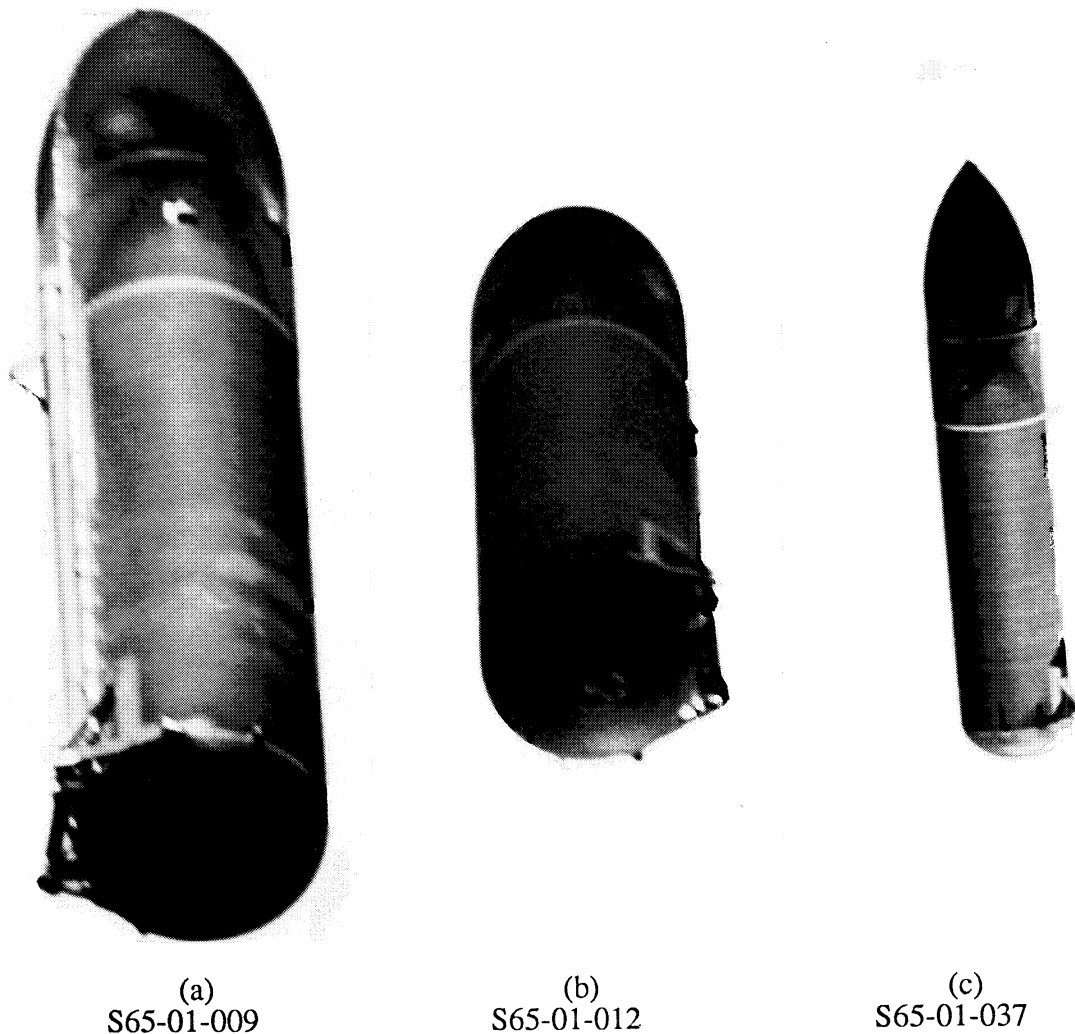
Figure 2.4.1 Three Handheld Views of the External Tank after Separation

These three views of the external tank were taken with a Nikon camera. Figure 2.4.1a shows the right side and aft end, (b) shows the aft end and left side, and (c) shows the left side. The ET appeared to be in good condition. Normal scarring from recirculation and SRB separation was visible.

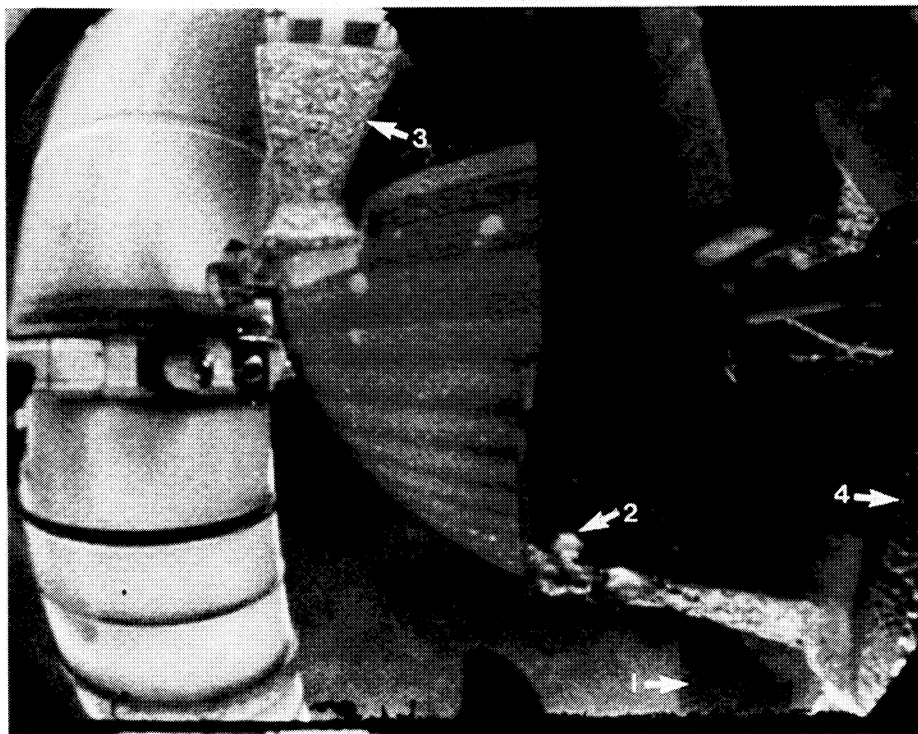
Figure 2.4.2.1a LSRB at Separation
(Frame S65-1013-1113)

A large piece of debris (probably insulation) was seen below the electrical cable tray at SRB separation (1). Typical chipping and erosion of the -Y electrical cable tray was visible (2). Erosion and scarring of the ET/Orbiter aft attach was seen (3). A blistering of the fire barrier coating on the outboard side of the LH2 umbilical was apparent (4). Several small light colored pieces of debris (probably insulation) were visible striking the electric cable tray prior to and after SRB separation. The SRB separation appeared as expected.

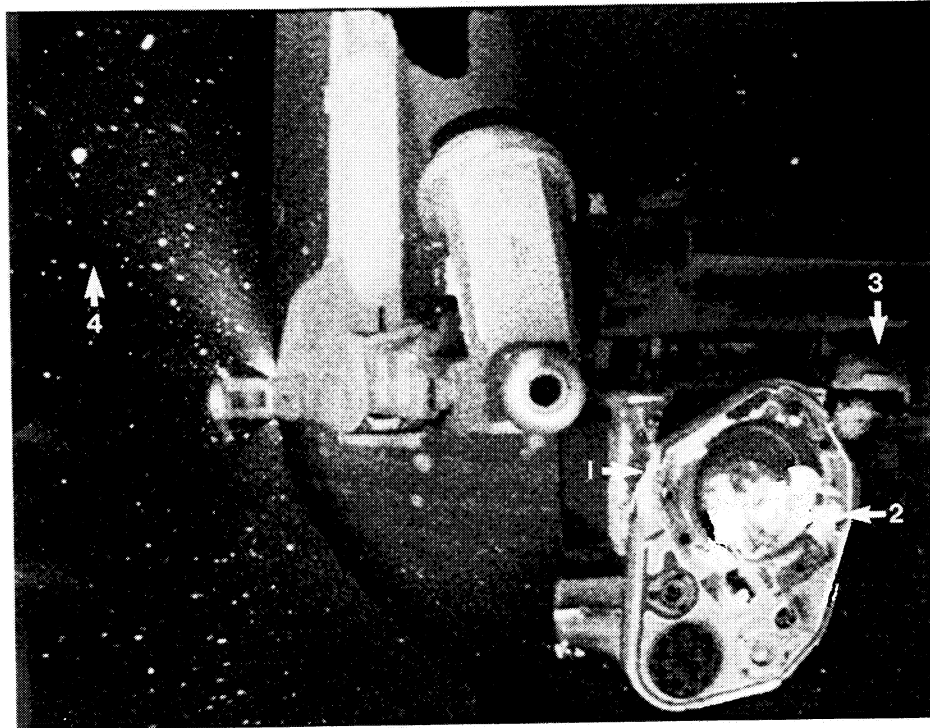
Figure 2.4.2.1b **LH2 Umbilical After ET Separation**
(Frame S65-1003-6100)

Damage to the insulation on the umbilical carrier plate was visible at the ten o'clock position. (1). Frozen hydrogen was visible in the LH2 17 inch line connection as well as in the area surrounding the 17" line (2). A light colored area (possible frozen hydrogen) was seen to the right of the umbilical on the ET (3). Small, bright debris was visible near the SRB aft attach point (4).

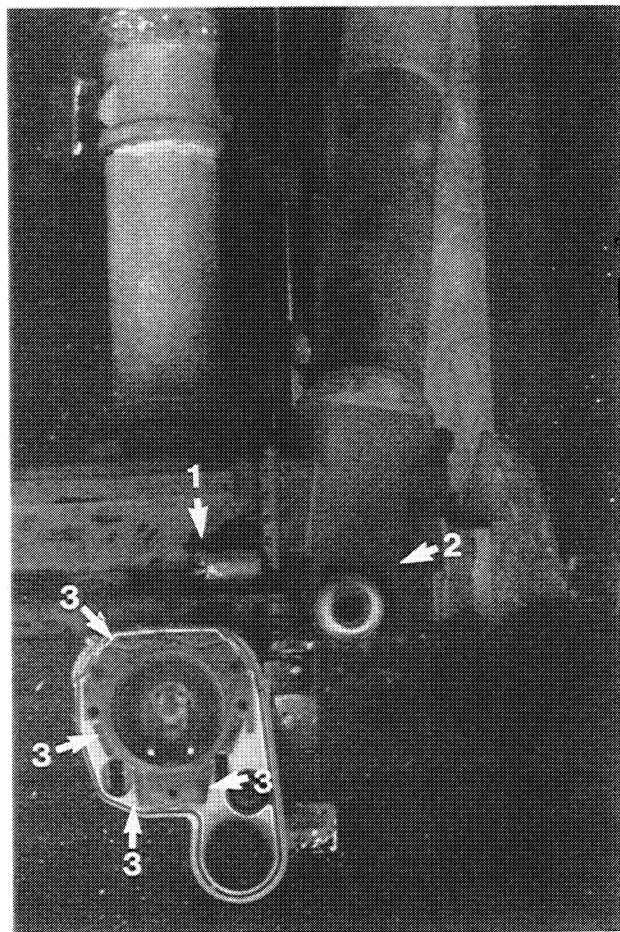
Figure 2.4.2.2b ET LO2 Umbilical and Aft Strut Area
(Frame S65-53-10)

Slight TPS erosion was visible on the aft section of the ET. All speckled areas observed on the 35 mm umbilical well film were verified on the closeout photographs. A divot was noted on the fixture between the diagonal strut and the crossbeam (1). The red seal around the EO-3 fitting appeared to be intact (2). Four of the five LO2 umbilical lightning contact strips did not seem to be present based on the absence of a metallic tone and edge relief typical to the surrounding area (3). JSC engineers were notified of the possible missing lightning contact strips.

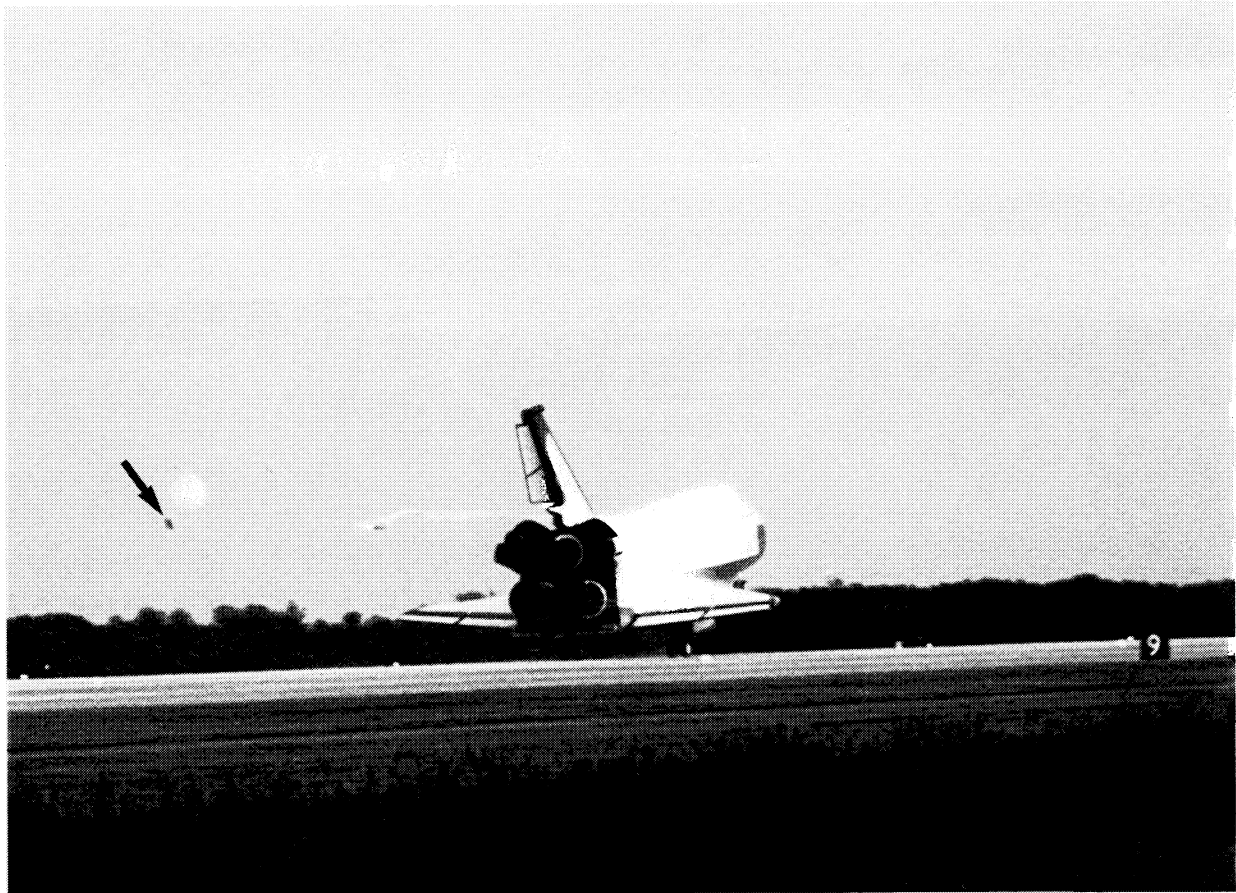
The landing of Columbia at the end of mission STS-65 marked the fifteenth deployment of the Orbiter drag chute. The pilot chute door appeared to drift behind the vehicle and pass near the pilot chute after bag release. (See Figure 2.6.2a). An impact with the pilot chute may have occurred. A study of the drag chute door and pilot chute trajectories relative to the Orbiter and the runway has been initiated. Analysis of the event is not yet complete.

Figure 2.6.2a **Drag Chute Door Trajectory**

This view of deployment shows the pilot chute housing door as the main chute is being unfurled. A study of the landing videos and films suggests that the door may have contacted the pilot chute after release.

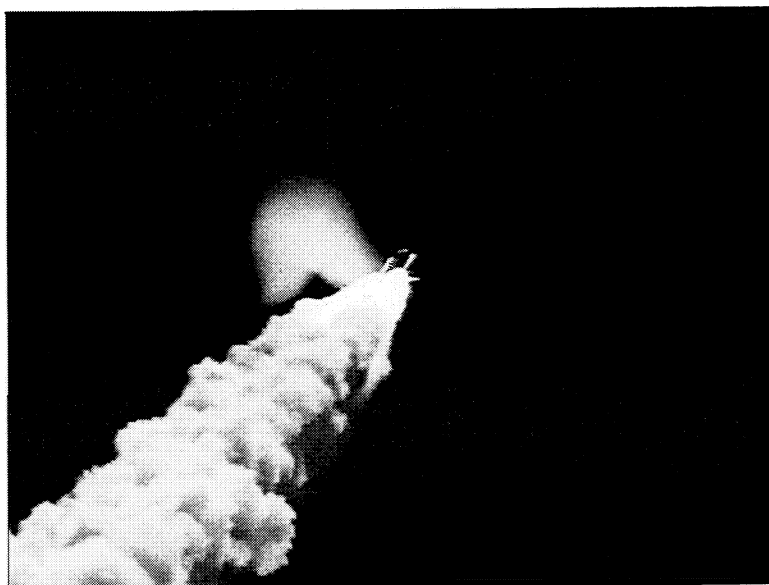
Figure 1. Condensation Cloud as seen from Camera TV5

An unusual condensation cloud formed as the vehicle ascended at 57.5 s MET. This cloud, as seen by camera TV5 is shown in Figure 1. The cloud did not appear to emanate from the vehicle. This cloud appears to form as a result of the shock wave passing through saturated air in the upper atmosphere. Figure 2 from camera ET-207 shows a close view at the time of cloud formation.

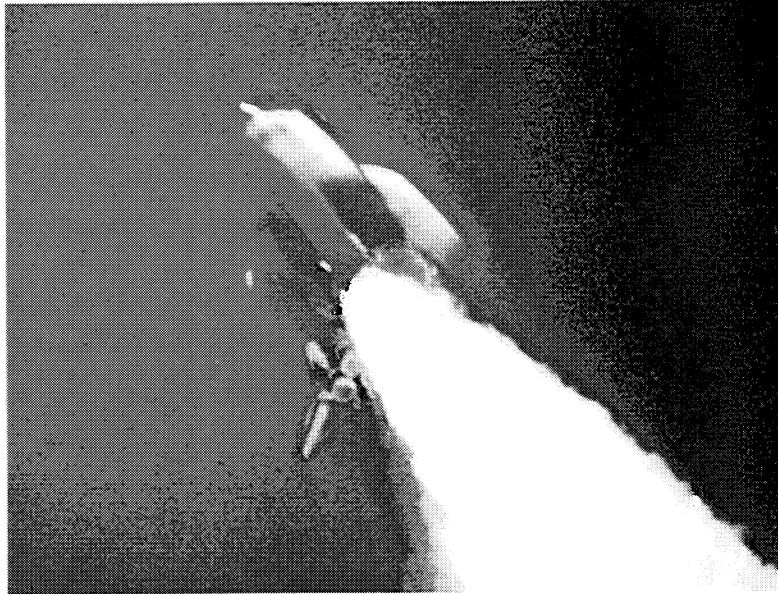
Figure 3 Condensation Collar as observed from Camera E-223

As the vehicle ascended, the condensation collar that usually forms around the vehicle was more pronounced and persisted longer due to the moisture content of the atmosphere. This collar is shown in Figure 3.

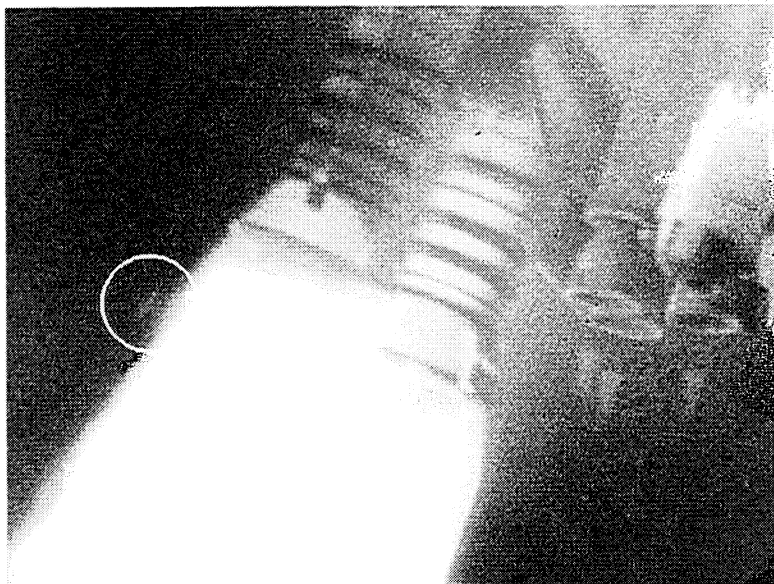
Figure 5 Thermal Curtain Tape as seen from Camera E-212

During ascent, at 49.23 s MET a piece of thermal curtain tape was noted falling from the vehicle by cameras E-212 and E-223 as shown in Figures 5 and 6 respectively.
